To Buy or Not to Buy?

STORY: Sue Rawle

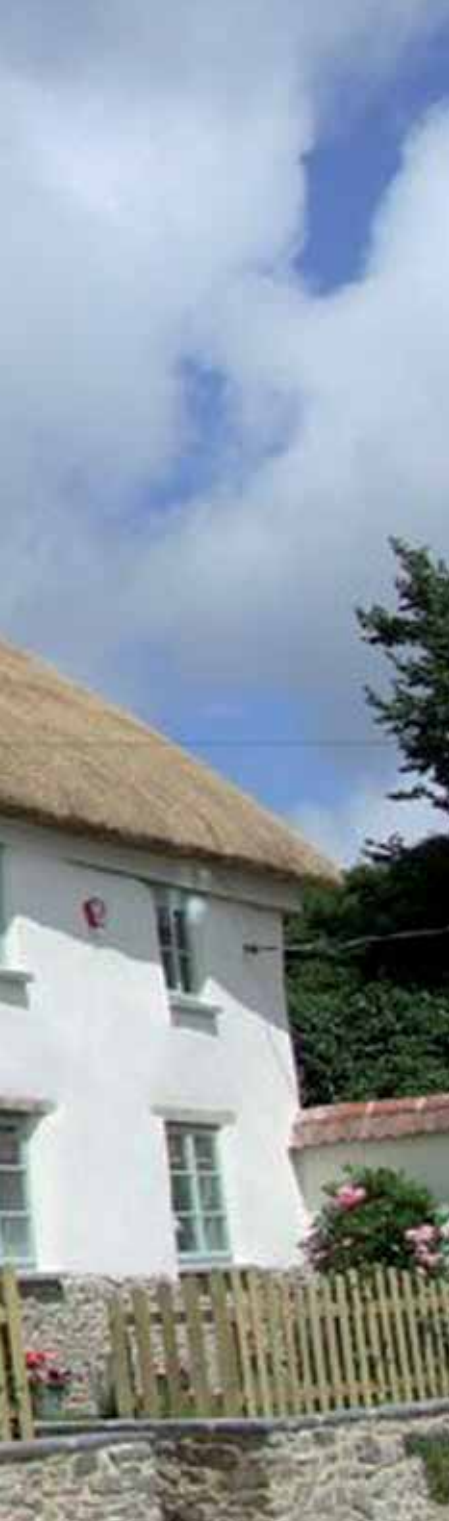
RIGHT: Modern paint on stonework waiting to be removed.

Inside, it's likely there are going to be damp patches on the walls because cement, unlike lime mortar, tends to trap moisture in the wall. However, don't despair. The situation can be remedied by digging off all the cement render, repairing any structural damage to the cob, and then re-rendering with lime mortar.

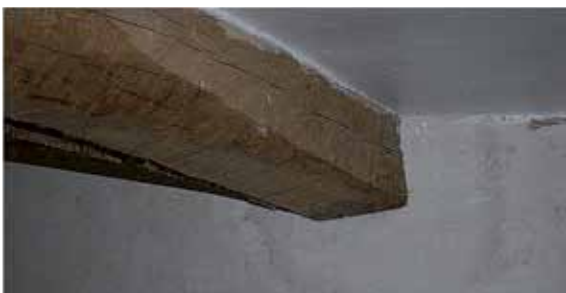
ABOVE: Beams may need replacing.

often affected by walls being covered in the wrong type of render, causing them to rot out. The same goes for beams, so don't be afraid to really look as closely as possible for any potential problems. Whilst you are looking upwards, venture into the attic, check out the roof trusses and the state of the roof itself- missing slates or thatch will have allowed water into the property and will need to be sorted before any restoration work begins. Same rules apply to the floor of course; keep an eye out for rotten timber-often a damp, earthy smell is an indication that there could be wood rot, dry rot or wet rot. This is where it can be very helpful to have an expert on hand to talk through the problems and take advice on the best way to remedy the situation.

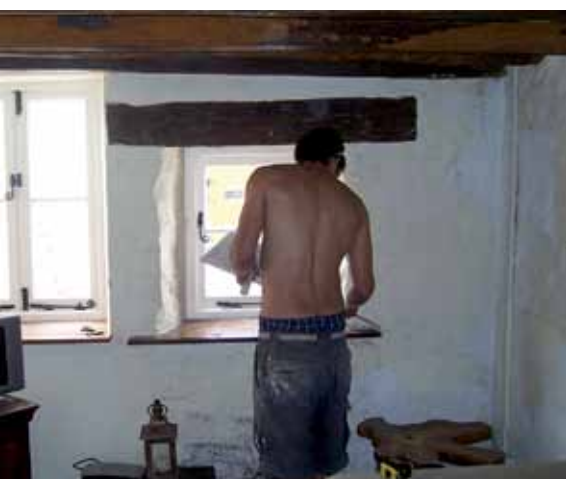
ABOVE: Note mildew on wall-stonework has been painted with modern paint.

If the interior walls have been plastered with pink plaster, painted with modern emulsions, or wallpapered, (a favourite in many old houses as it hides a multitude of sins), there will probably be obvious signs of mildew or damp. The wallpaper may have come away from the wall, the paintwork peeling or flaking, but by removing the offending 'modern' materials and re-plastering with lime mortar, the problem can be overcome.

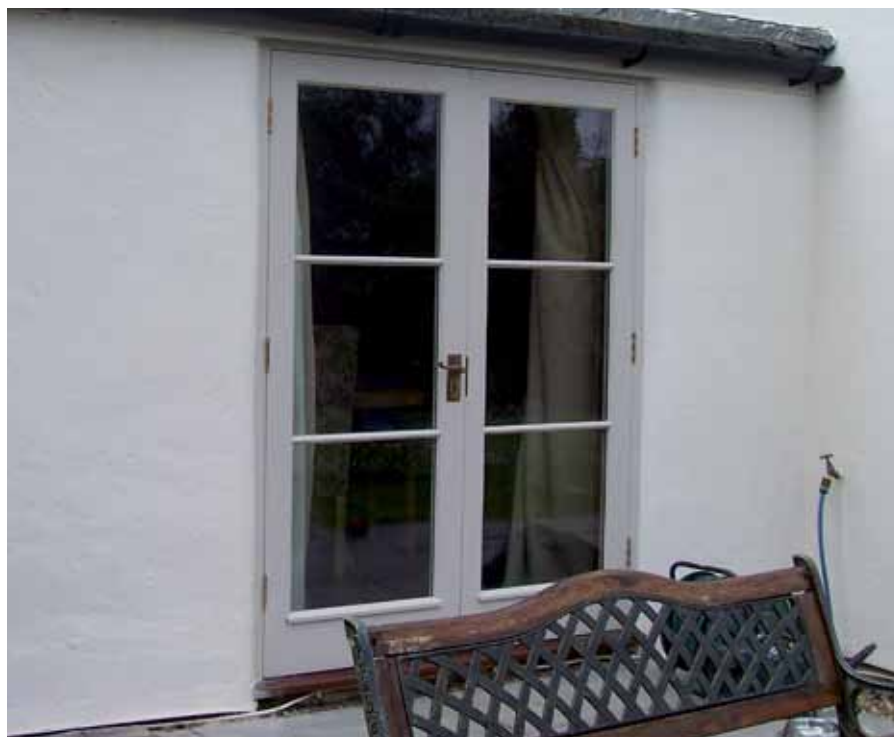
ABOVE:
These doors have been handmade by our carpenter to replace the old doors which had seen better days.

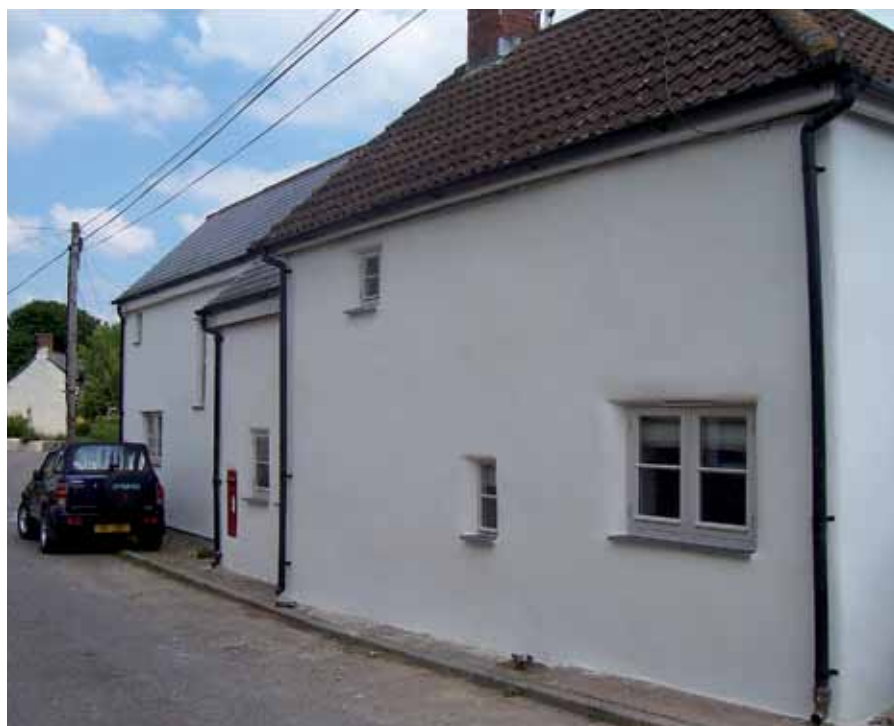
BELOW:
The end result of using the right materials is worth the effort.

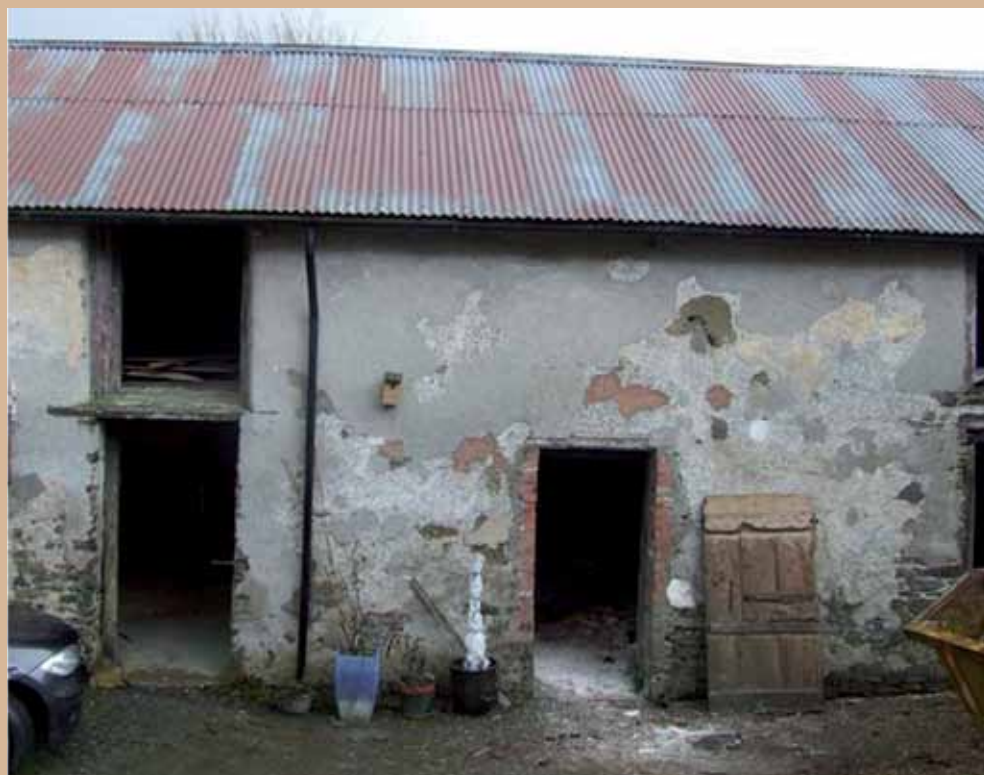
ABOVE:

Undertaking renovation of a barn is not for the feint hearted.

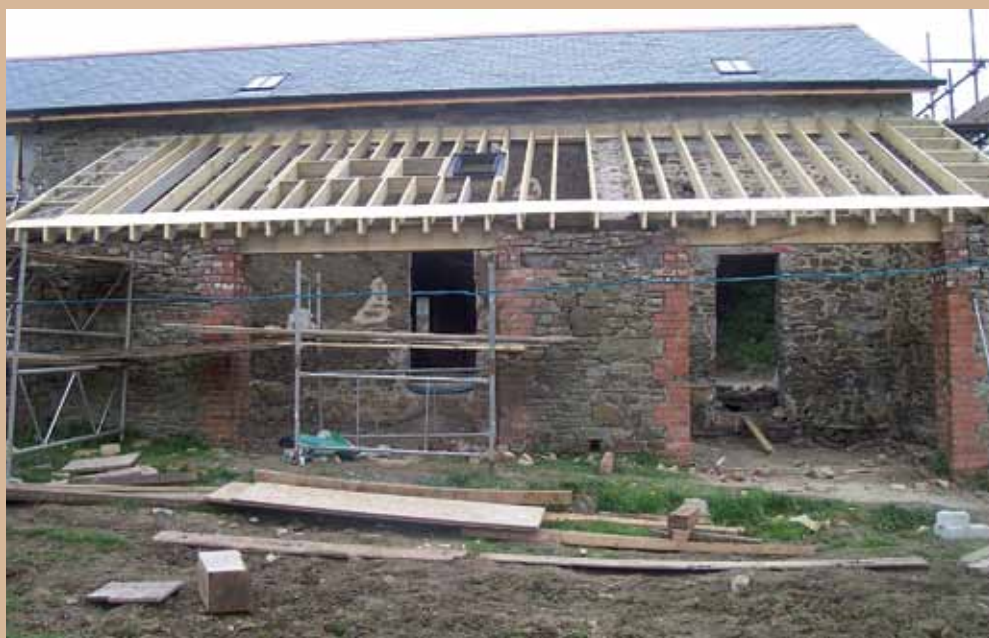
CENTRE:

Renovating a barn roof.

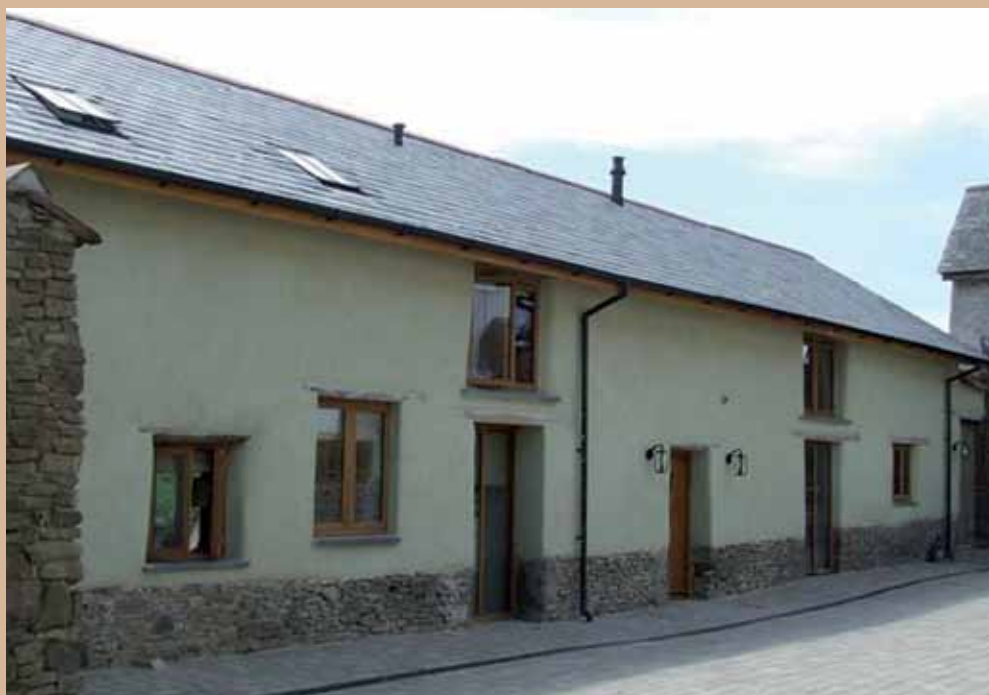
BELOW:

Barn conversion undertaken with correct materials of lime mortar

There is a solution but it's going to be time consuming and carry a considerable cost. Apart from major building work involving steel girders to hold the frame of the house together, all the cement has to be dug out from the stonework and re-pointed with lime mortar. Inside, the same applies to any stonework used as a feature, as well as all the cement and plaster having to be dug off and replaced with lime mortar, before being painted with breathable limewash. The end result will be worth waiting for because once remedied, there is no reason why a barn conversion like this won't still be standing in four hundred years time.
