# Restoration – Cherish those Quirky Finds

*Here at Heritage Cob and Lime, we meet some lovely people and get a chance to work on houses that are both inspiring and interesting. One such project recently took us to the tiny village of Shop, near Morwenstow, North Cornwall, where Cobwell Barn awaited a major restoration.*

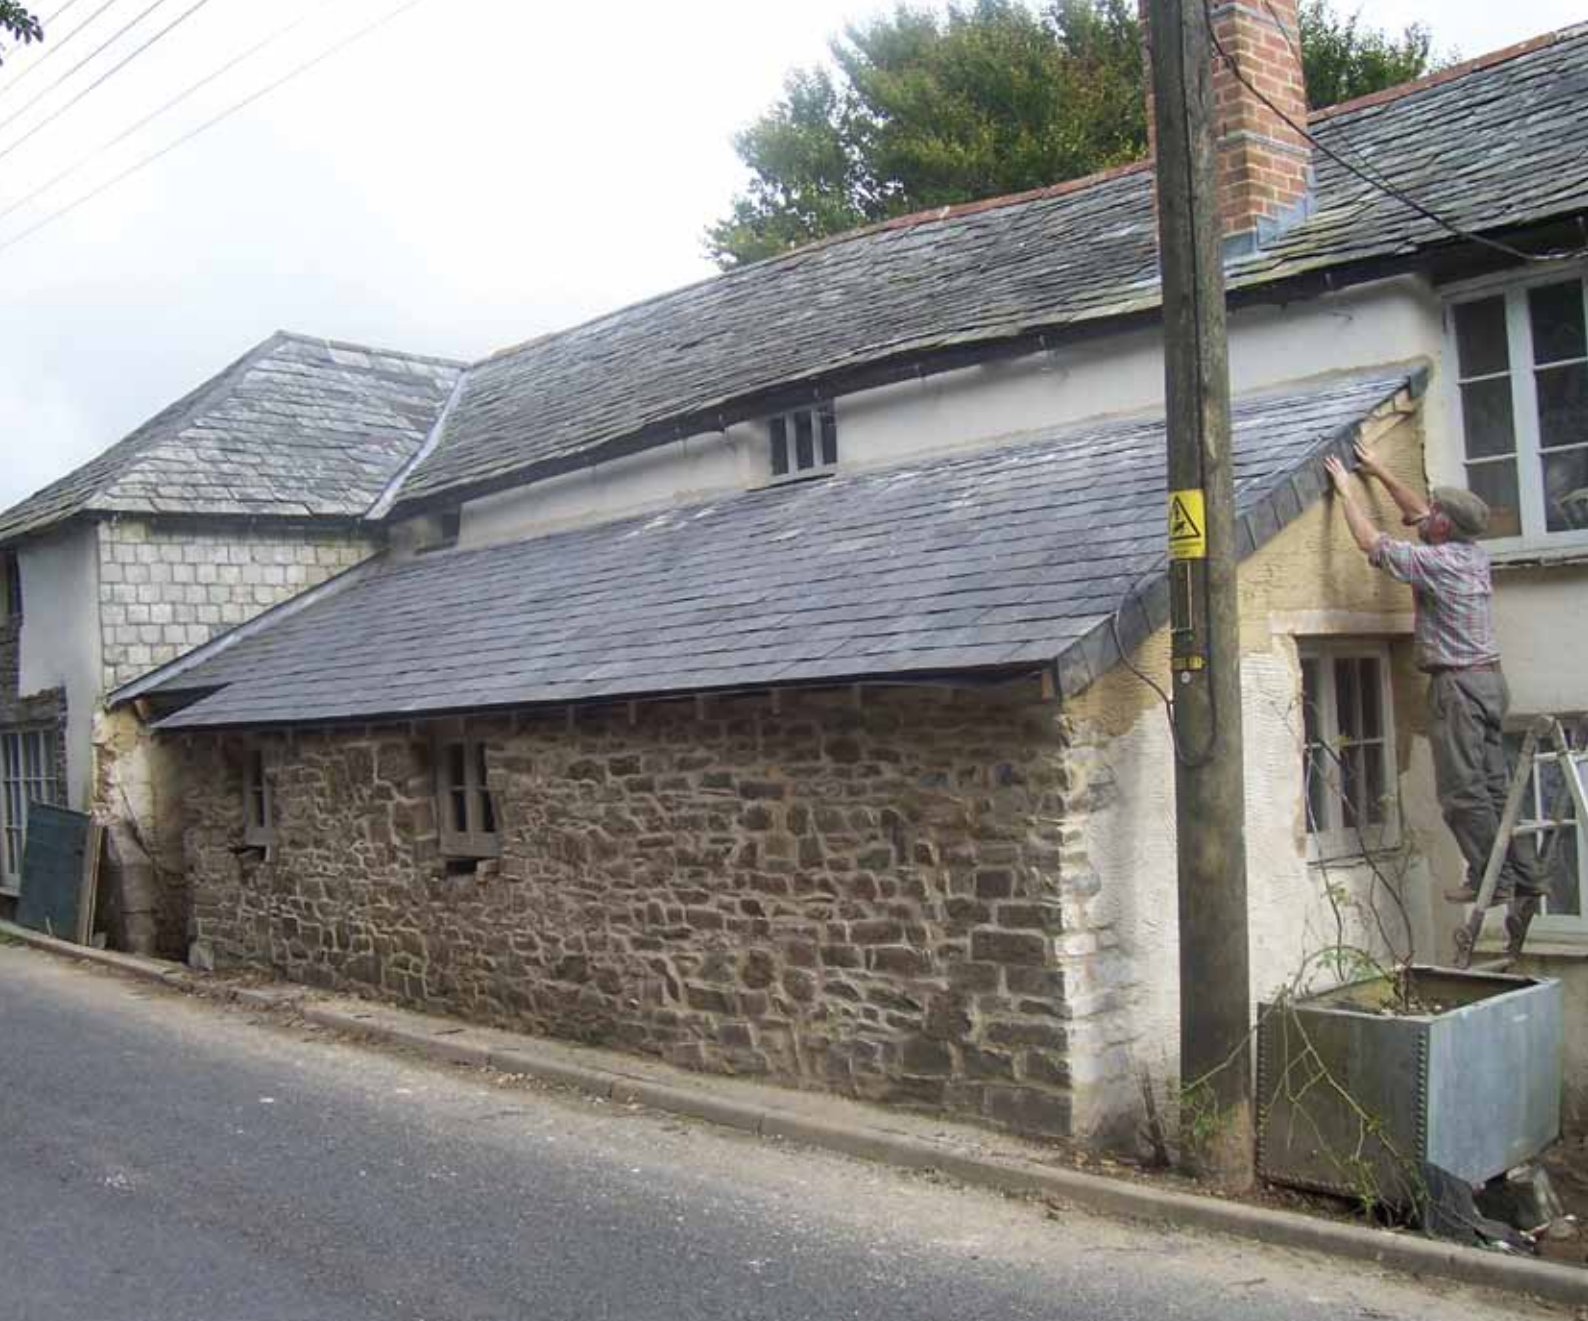
**LEFT:** Windows in place, stone work re-pointed with lime mortar. **ABOVE:** Slates are off, roof awaiting repair.  
**BELOW:** The well- it looks small but goes down 30 feet and turned out to be 6 feet in diameter.

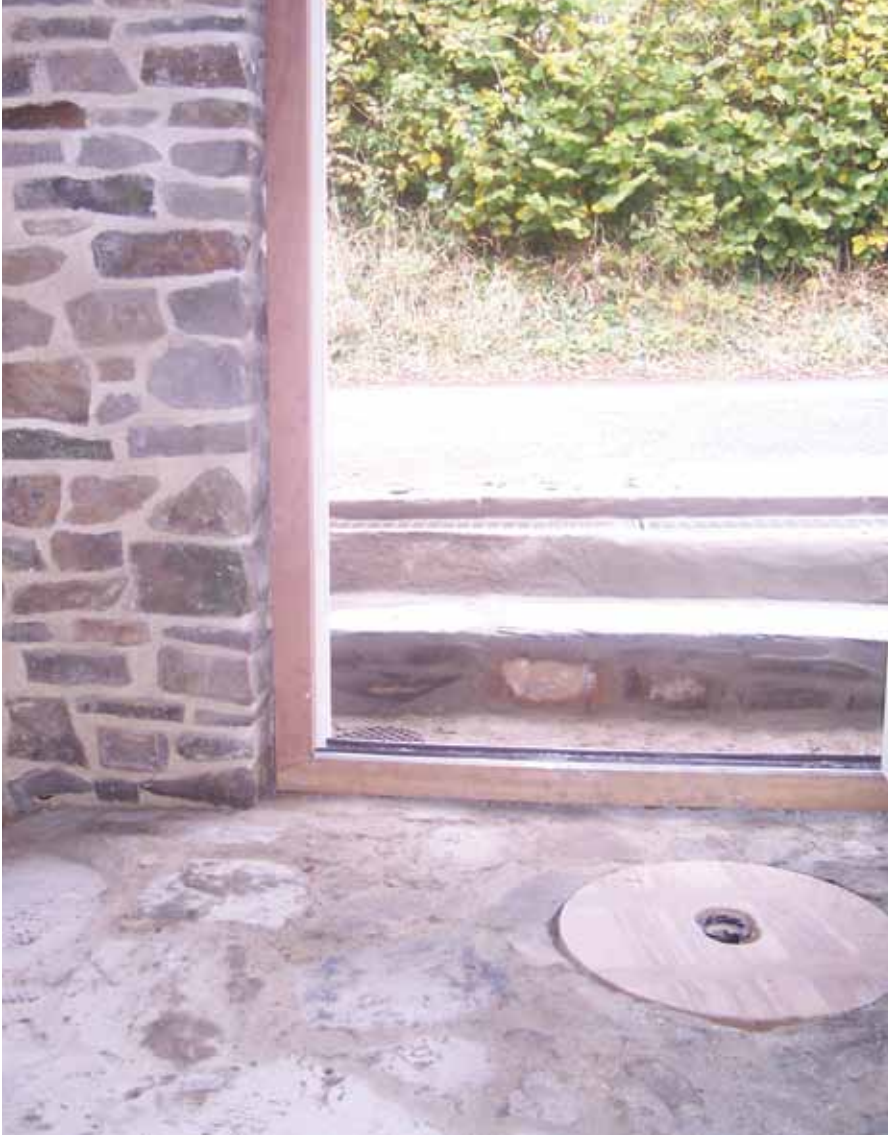
**ABOVE:** Cobbling around well cover, pillar re-pointed with lime mortar, and steps now in situ. **BELOW LEFT:** Stain glass window in place- walls rendered with lime mortar. **BELOW RIGHT:** Wall in annexe lime rendered, leaving feature of window and beam showing

front door, and as the owners wanted to retain the well as a feature, it had to be safe to walk on yet left intact as part of the historical fabric of the building. A heavy duty iron mesh was designed by our team and fitted into place and then a local carpentry firm, WJB Carpentry, made a wonderful wooden inspection cover from American oak. The result is a fascinating talking point when visitors step through the front door.

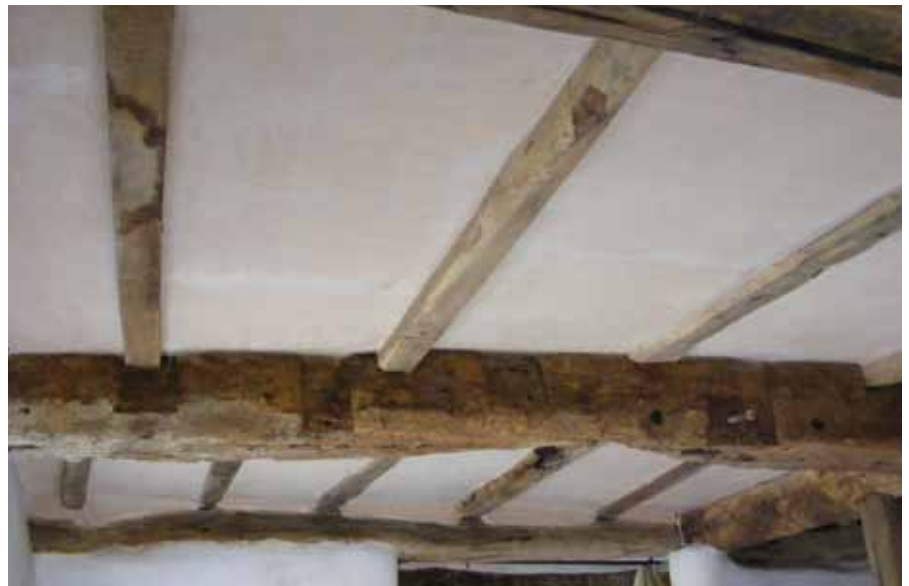
**ABOVE:** Ceiling restored, orange foam filler banished. **BELOW:** New staircase in place- walls re-rendered with lime mortar.

the natural delineations of the stones. A new interior door was fitted with glass panels to allow light to flood into the sitting room. Work now began in earnest on the ceiling, finally ridding the house of the unsightly orange foam filler that had rather dominated the décor when used by

a previous owner to fill gaps in ceiling and walls.
