Preserving Historic Stonework

STORY: Sue Rawle

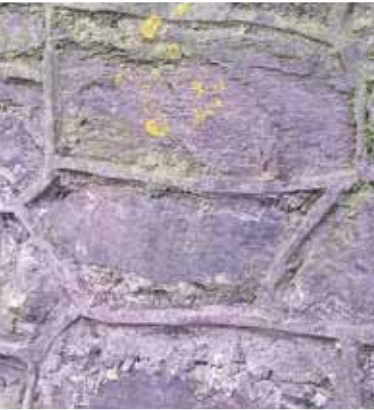
ABOVE LEFT: Example of strap pointing- already damage to the stone is evident.

A classic example of how not to restore stonework can often be seen when viewing stones that have been 'strap' pointed using cement render, which can lead to serious damp issues on the adjoining internal wall. Strap pointing usually stands away from the face of the stones and should be avoided at all costs. Not only do the wide joints dominate the appearance of the wall, but they can also harm the fabric of the building. In this instance, the pointing between the stonework should be dug out and replaced with lime mortar which ideally should match the colour of any existing mortar.

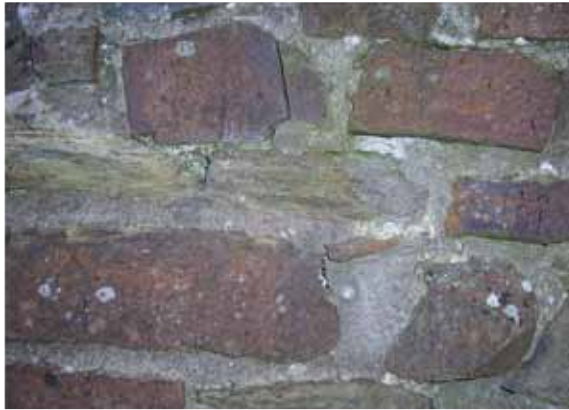
ABOVE CENTER: Cement render before being repointed with lime mortar- notice the cracks that have appeared.

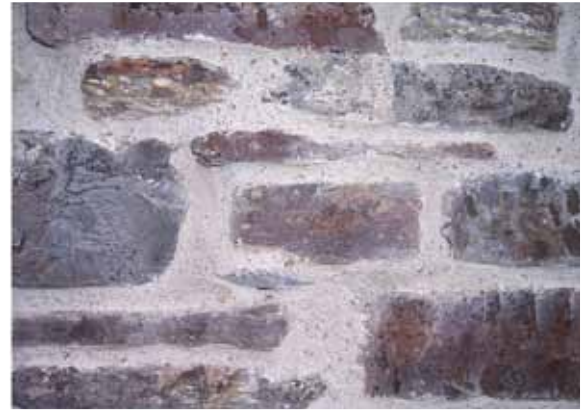
ABOVE RIGHT: Cement Strapping replaced by lime mortar.

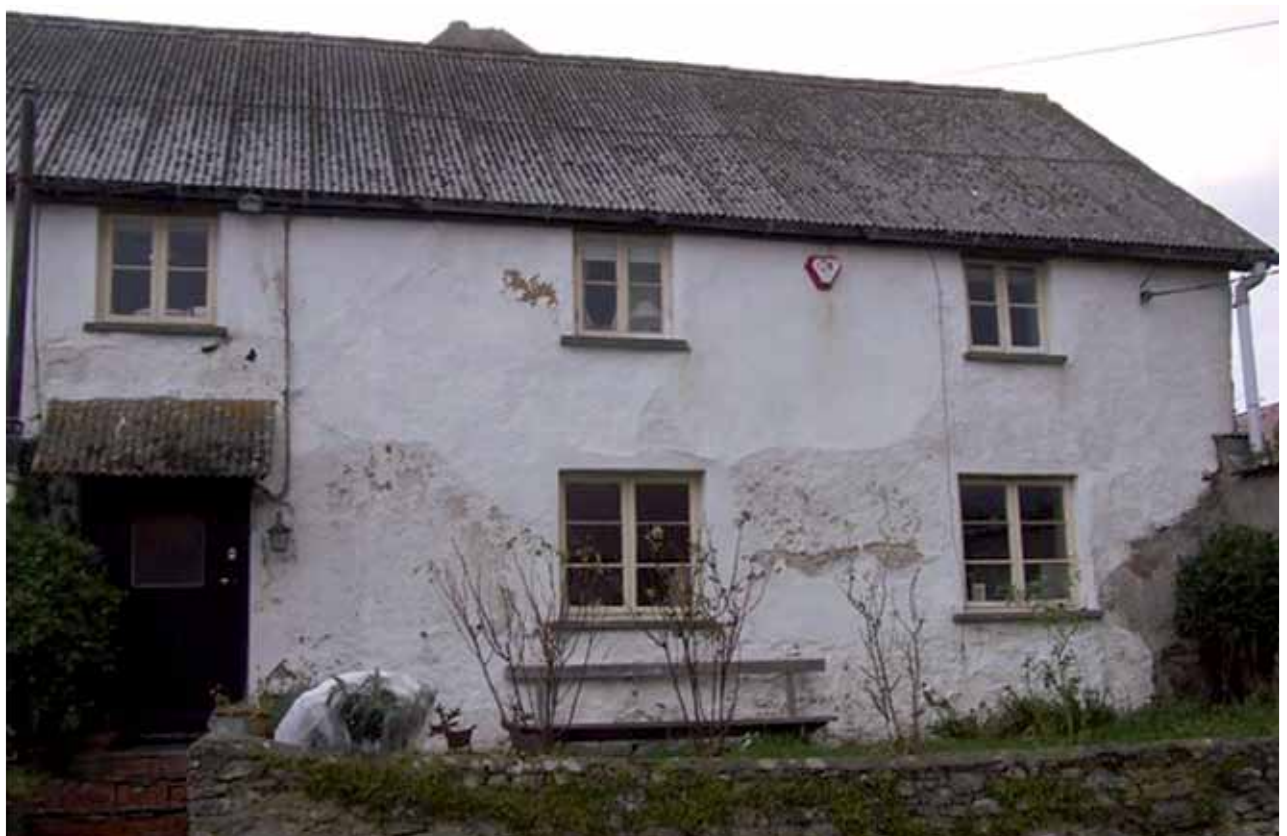
BELOW: Stone wall and building before restoration.

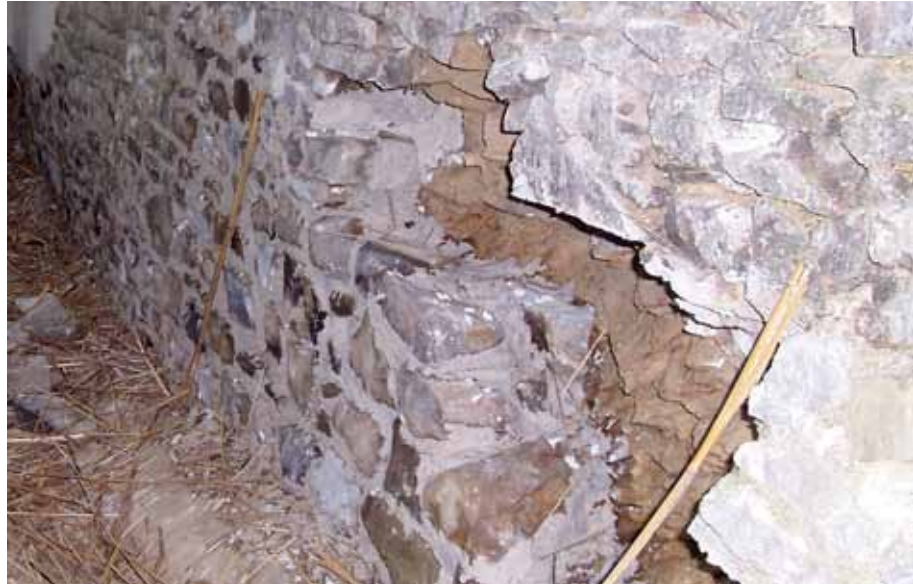
ABOVE: Early stages of restoring decayed stonework.

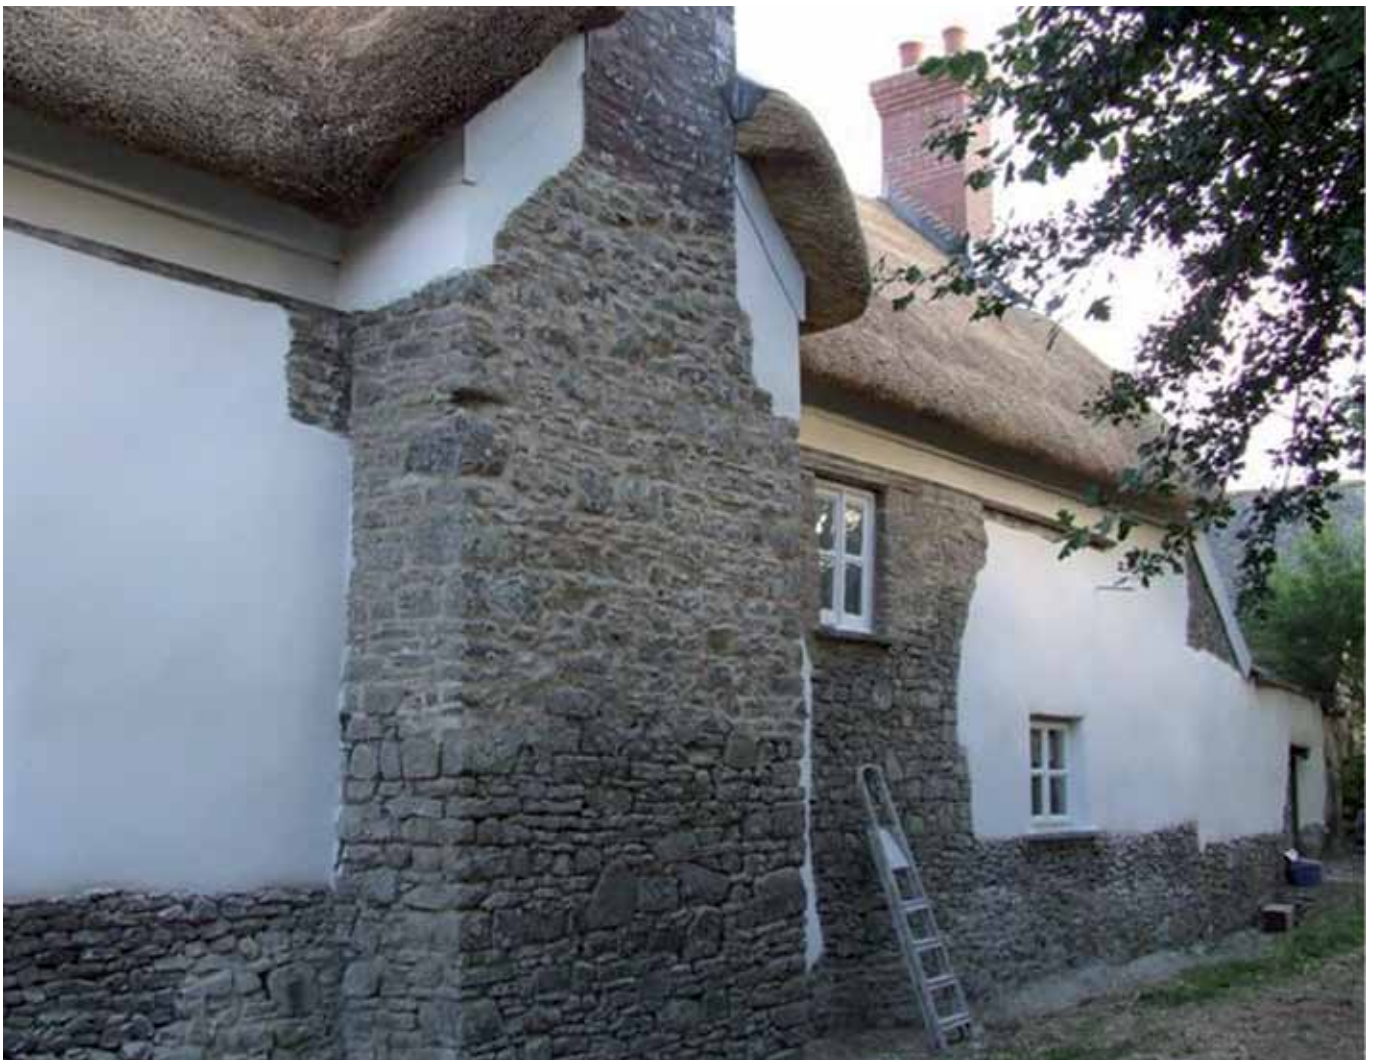
BELOW: Walls have been rebuilt and together with the stack are in the process of being repointed with lime mortar.

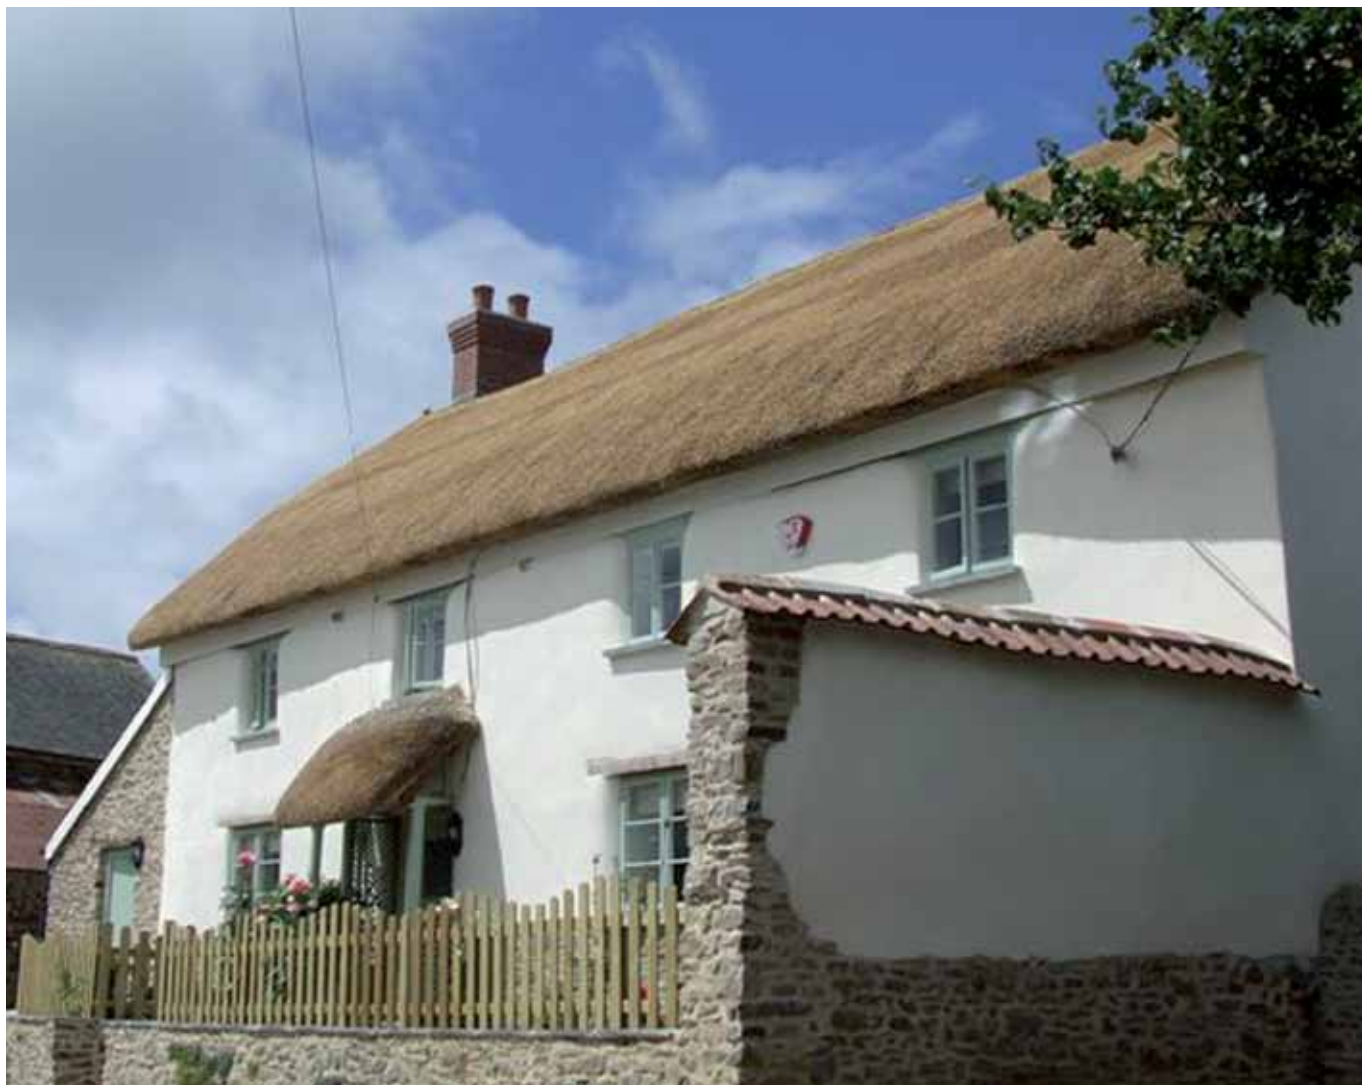
ABOVE: Stone wall and building after restoration.
