Get a Good Hat on Your House

STORY: Sue Rawle

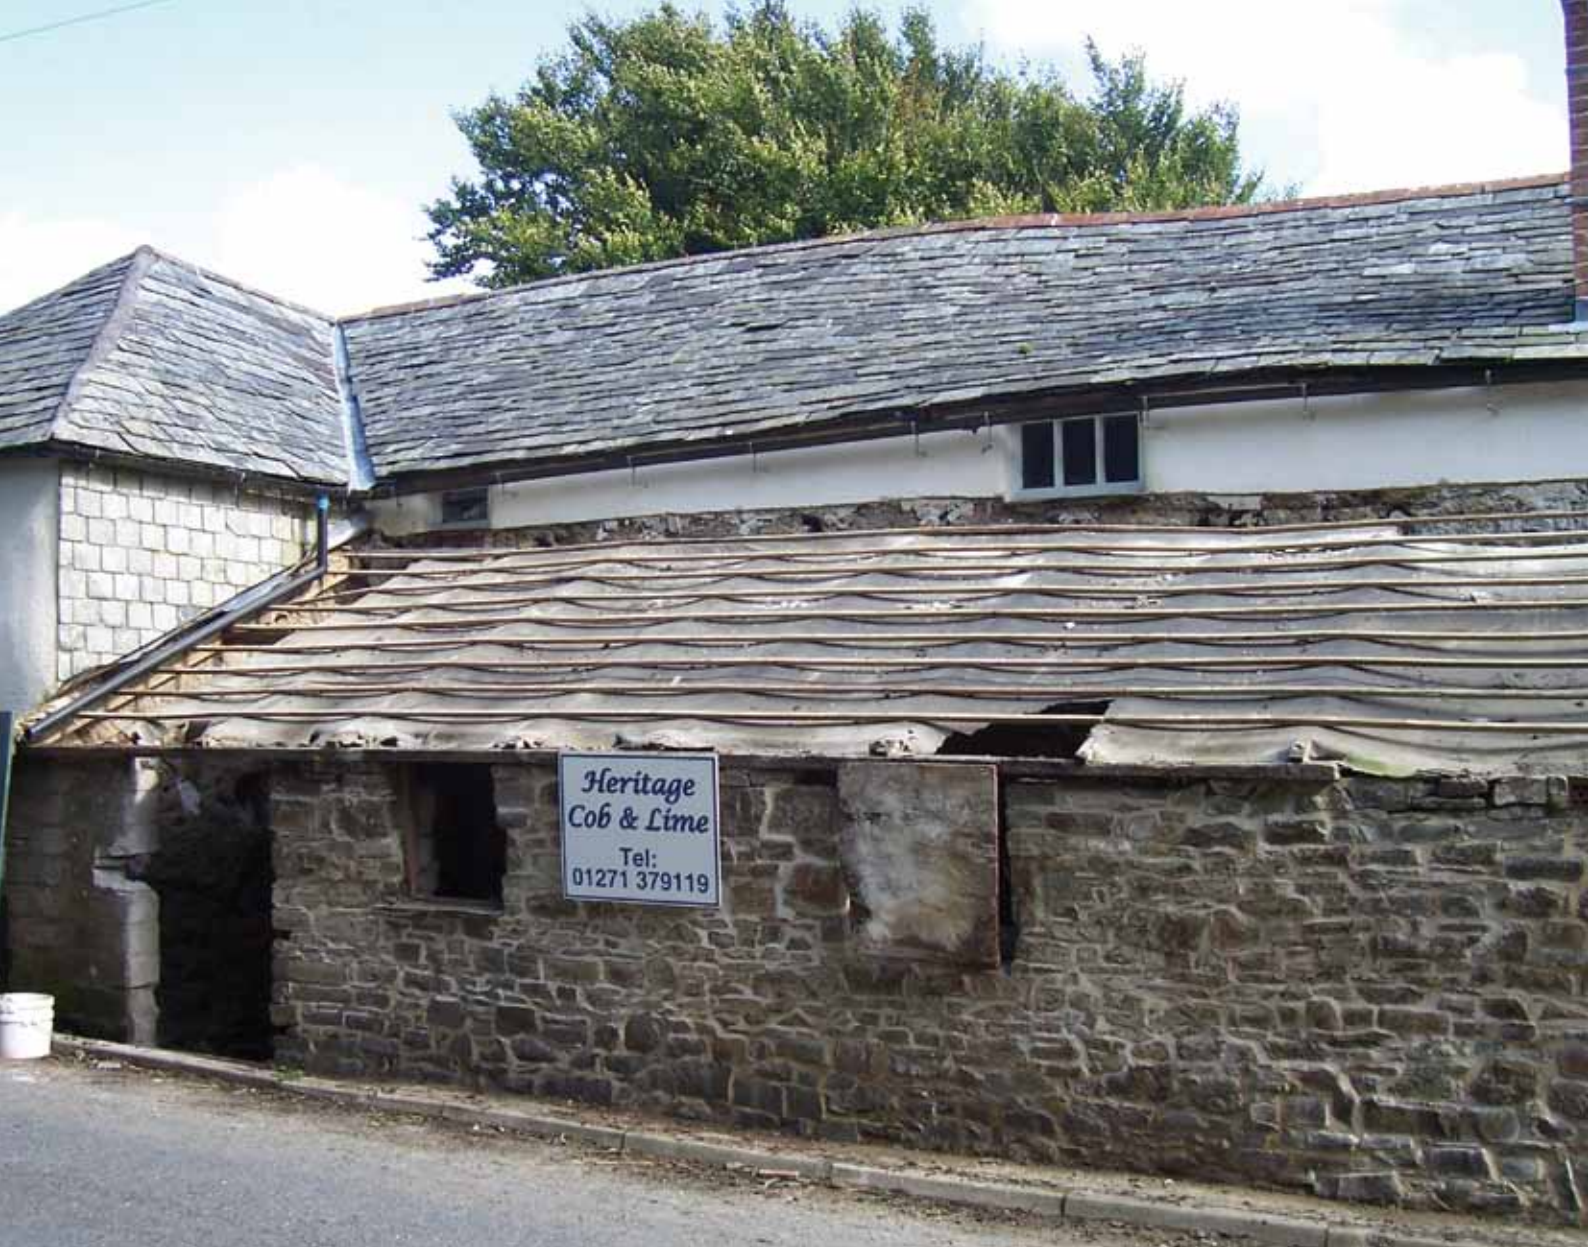
LEFT: Although it looks in a poor state, this roof had kept the rain out. **ABOVE:** New roof under construction.
BELOW: Despite the roof being in need of repair, this annexe has stayed dry inside.

Last year we undertook work in gutting an annexe and rebuilding it, complete with a new roof. Although it looked in poor repair, it was in fact dry inside, despite the roofing felt having numerous holes. The Cornish slates had done their job and kept out the elements over the past one hundred years. Before this the property was thatched as we saw by a very early photograph, however as it was not Listed the owners were allowed to use natural slate to replace the old roof. It's simple by design and in keeping with its environment and the neighbouring properties and of course, more to the point, protects the occupants and their home. By using vernacular methods of construction and locally available resources in a traditional T style, the roof is atypical

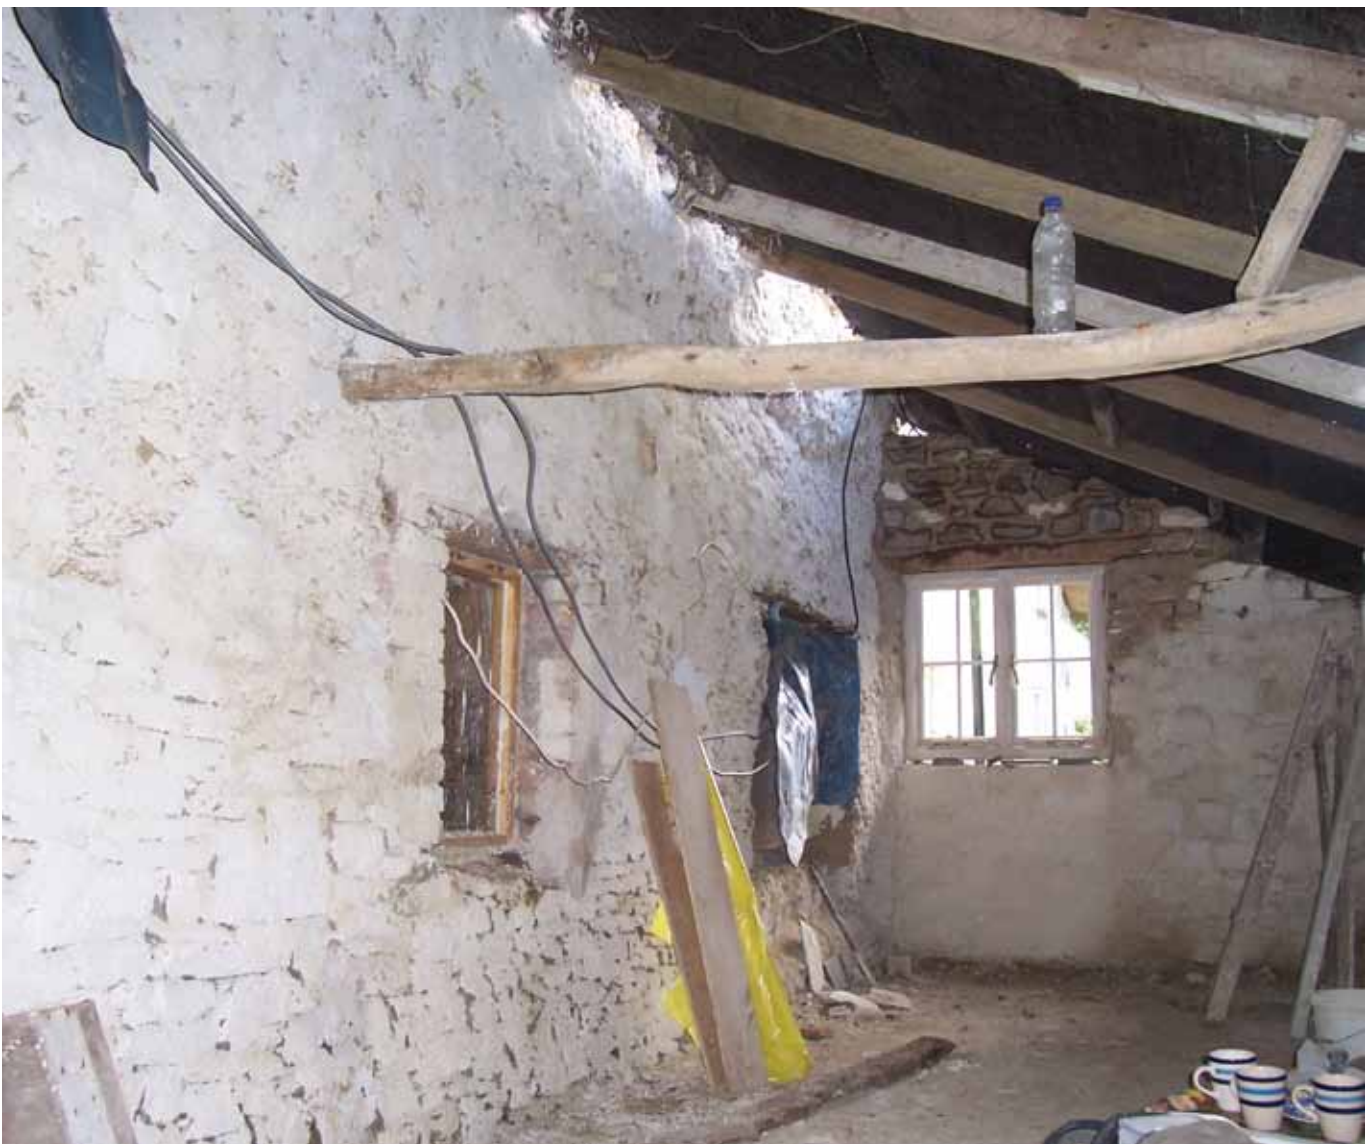
ABOVE: The overhang of this roof has kept the cob dry and stable. **BELOW:** Slates on and Watertight!

a wall plate but rather straight onto the bare cob. The old roof didn't have a large enough overhang to protect the cob underneath and so little by little, the cob was getting damp, disintegrating and becoming unstable.

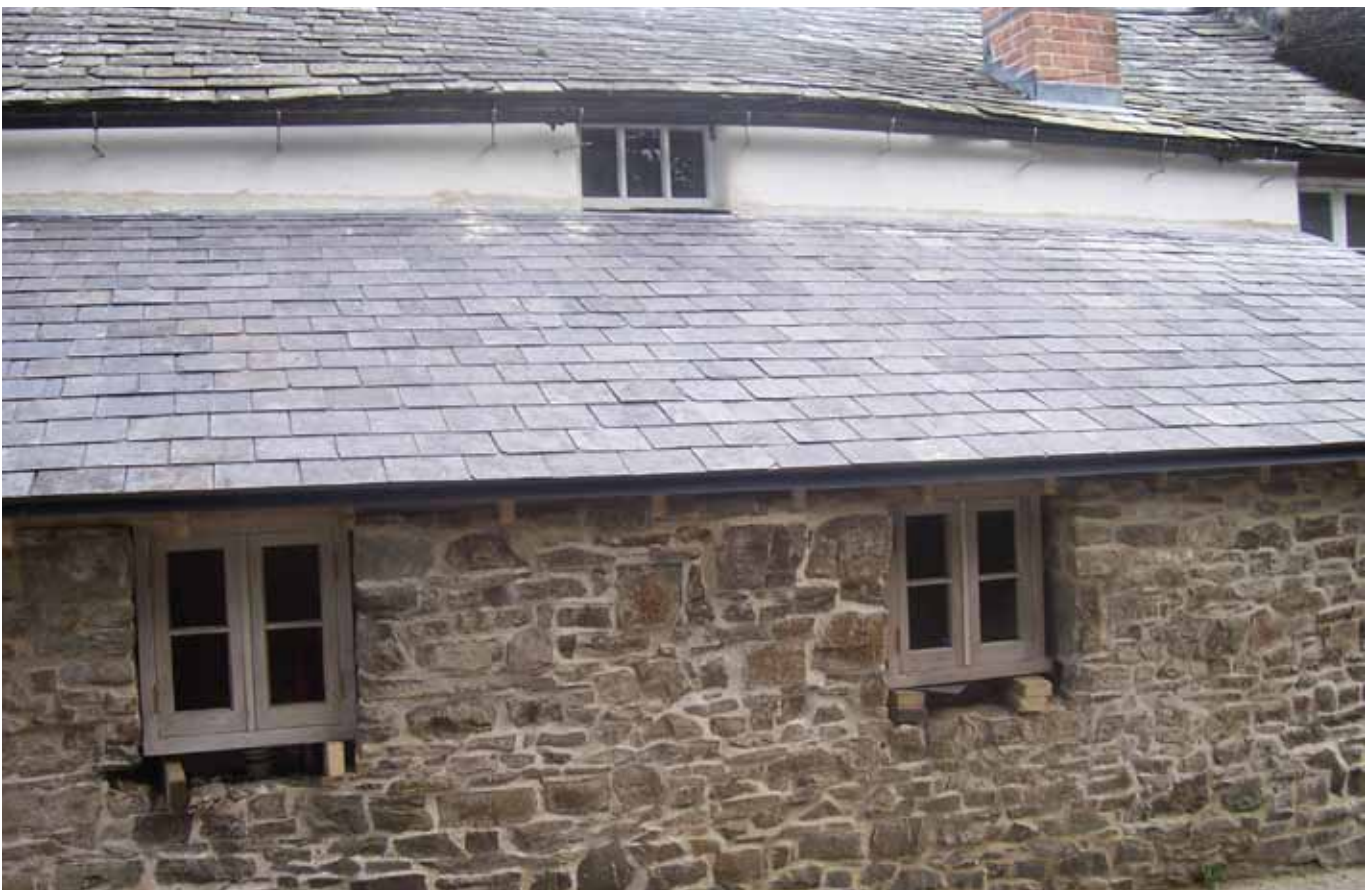
ABOVE: Before work begins removing existing roof and replacing with thatch. **BELOW:** New thatch has replaced old roof.

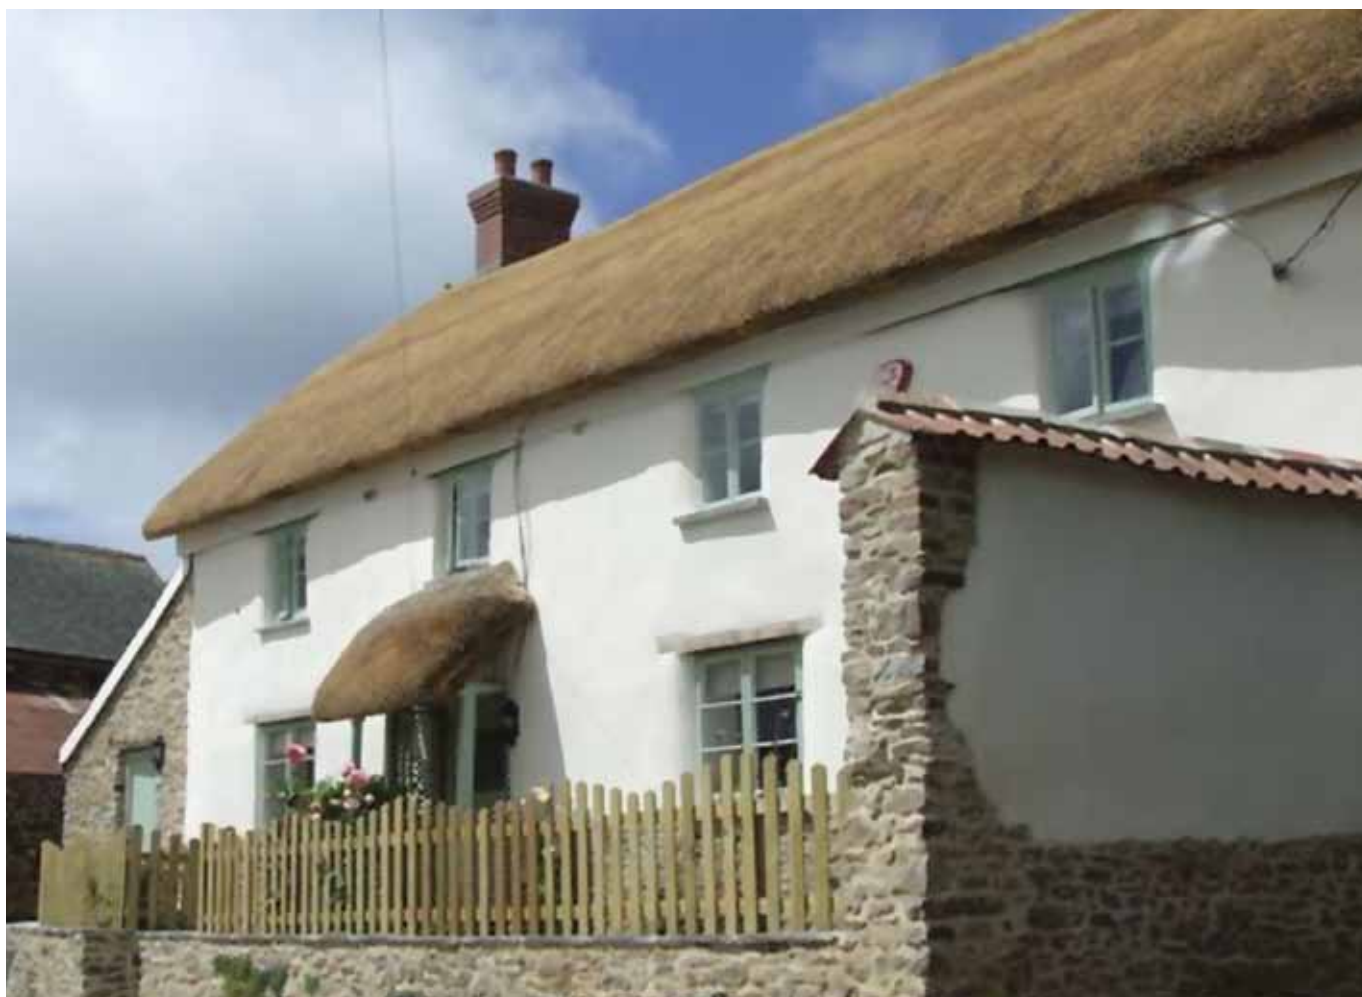
ABOVE: New Thatch and looking a picture. **BELOW:** Wood and Lime Mortar make good bedfellows.

We love to see the use of natural timber in old buildings and it fits so well with cob and lime mortar. Whether it's being used for beams, lintels, doors or windows, timber has a lovely warm quality that is so in keeping with older houses. Of course, like so many restoration assignments, the project can appear to be slow at the start. To begin with the old roof sat perilously on top of cob walls that were in a state of disrepair. It had been badly built and wasn't set on to
